Berrima Colliery -Closure Working Group

Mittagong RSL 13 August 2018

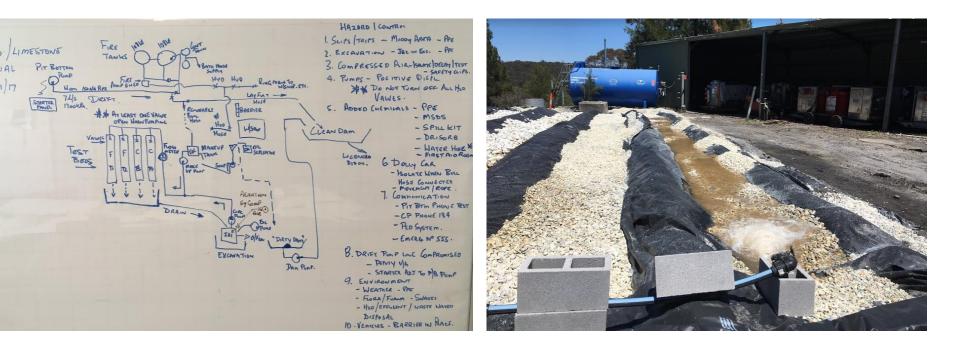
Pit top trials during November 2017 were used to design underground treatment trial
